## Evaluation Pavement Distresses for Runway Asphalt Using Pavement Condition Index (PCI)

### A Case Study Sabha International Airport

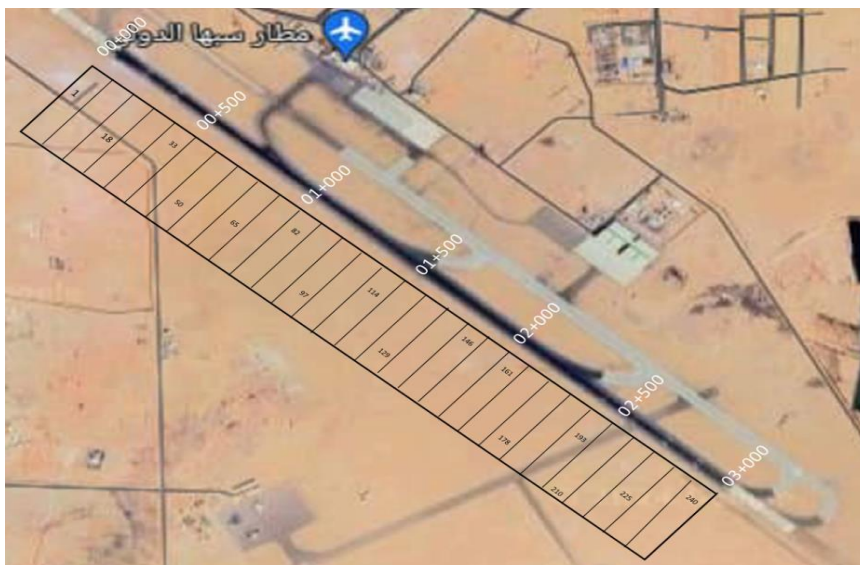
Figure (2). Satellite image of Sebha Airport, divided into 30 segments and sample units

This field survey has been done at Runway 13-31, with the total areas observed, are 3000 x 45 m<sup>2</sup>, divided into 30 segments, with an area about 4500 m<sup>2</sup> per segment as showing in figure 2.

The pavement was divided into sample units with an area ranging from 450 ± 180 m<sup>2</sup> in line with the literature.

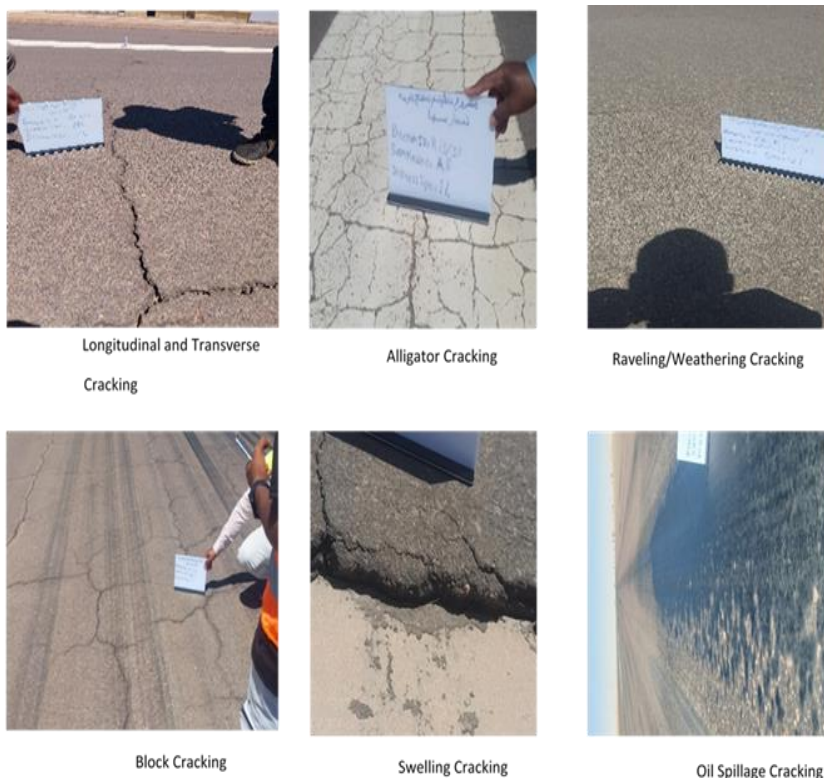
Figure (4). Several types of distress on the runway fixable surface on RY 13/31

Several site investigations were carried to collect the required data about distresses. Based on the results of visual inspection, several types of distress were examined on the runway surface of Sabha International Airport, such as longitudinal and transverse, alligator cracking, raveling / weathering, block cracking, swelling cracking, oil spillage cracking. Figure (4) below show several types of distress on the runway fixable surface on RY 13/31.

As a result of the distress survey and assessment process for the landmark (RY 13/31) as shown in table (2), the types of distress found in the sample units were very similar, if not identical and completely duplicated. The types of distress are limited to alligator cracking at 100%, and block cracking at 100%. The difference lies in the distress of longitudinal and transverse cracks at 66.67%, and weathering/raveling at 45.67%. As for swell distress, and oil stains in one sample model only at 7.14%, Figure (4) shows a group of images of the distress that were identified in the runway (RY 13/31),

and the rest of the images of the distress that were identified in the runway are shown in figure (4).

The process of determining the required maintenance level is based on the evaluation results of the pavements by matching the average pavement condition factor for the features that make up the flexible pavement of the Sebha International Airport runway with the pavement condition assessment scale and maintenance levels (PCI rating scale and repair levels). Table (4) shows the required maintenance levels for the flexible part of the Sebha International Airport runway. It is noted from this table that the required maintenance level for runway RY 13/31 falls within the maintenance level (reconstruction) and this maintenance level constitutes 100% of the total area of the flexible part of the runway under study.

Branch ID	Branch Area m <sup>2</sup>	Average PCI	General PCI Rating	maintenance and rehabilitation
RY 13/31	135000	40	Poor	Reconstruction
