Evaluation of Weld Defects in Petroleum Pipelines Using X-Ray for MAG, TIG, and SMAW Techniques

Hosam Almabruk Alnaily, Tariq Ramadan Aboalhol

The Libyan Higher Technical Center for Training and Production
Hosamalkaber1985@gmail.com

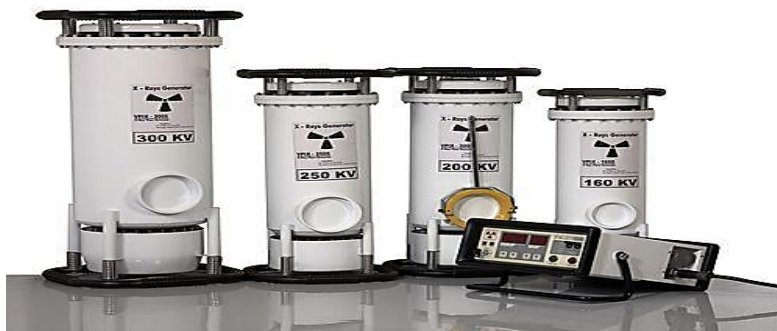
Figure 1. X-ray radiographic testing machine

In this research, we investigate welding defects in three different pipe welding techniques using X-ray imaging testing, Figure 1.

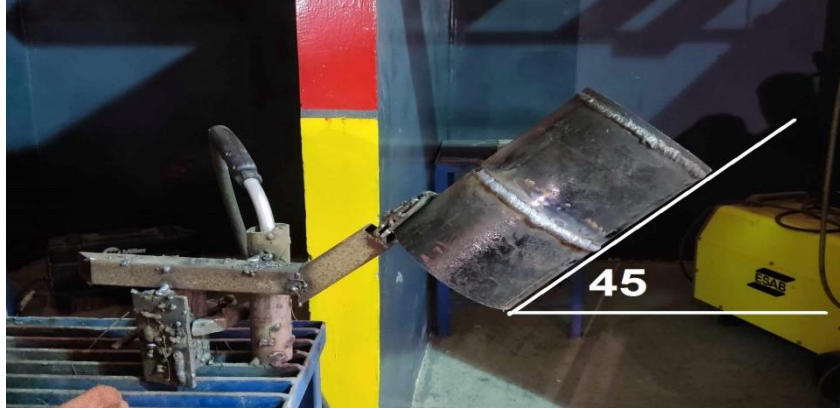
Figure 6. 6G welding position

The 6G welding position, a specific technique for pipe welding, was utilized in this study. Figure 5 shows various pipe welding positions, and Figure 6 illustrates the position of one of the samples during the welding process.

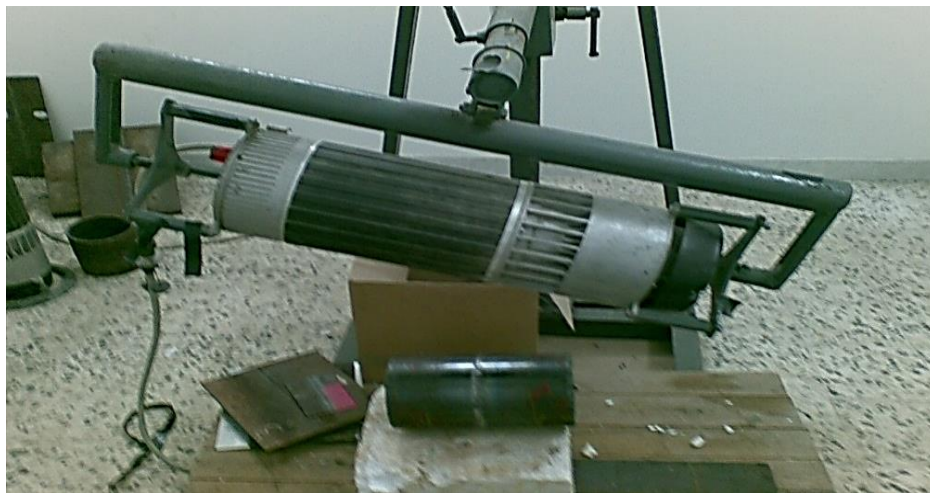
Figure 7 illustrates the X-ray machine and the 45° imaging angle used to avoid defect overlap in the film. In the attached image, the target area is the surface touching the ground, with the film placed underneath. The tube was rotated after each imaging process to ensure the entire weld line was captured, with each sample having three radiographic films taken.

Figure 7. X-ray machine and imaging angle at 45°

The procedure for conducting the imaging process is shown in Figure 7 and summarized as follows:

The X-ray device was positioned at a 45° angle.

The radiographic film was placed directly under the area to be inspected.
